1. AGENCY USE ONLY (Leave blank)		2. REPORT DATE 09/00/55		3. REPORT TYPE AND DATES COVERED
4. TITLE AND SUBTITLE REPORT ON GROUNDWATER CONTAMINATION, ROCKY MOUNTAIN ARSENAL, DENVER, COLORADO			5. FUNDING NUMBERS

GROUND WATER CONTAMINATION

CORPS OF ENGINEERS, U. S. ARMY
OFFICE OF THE DISTRICT ENGINEER
OMAHA DISTRICT
OMAHA, NEBRASKA
SEPTEMBER 1955

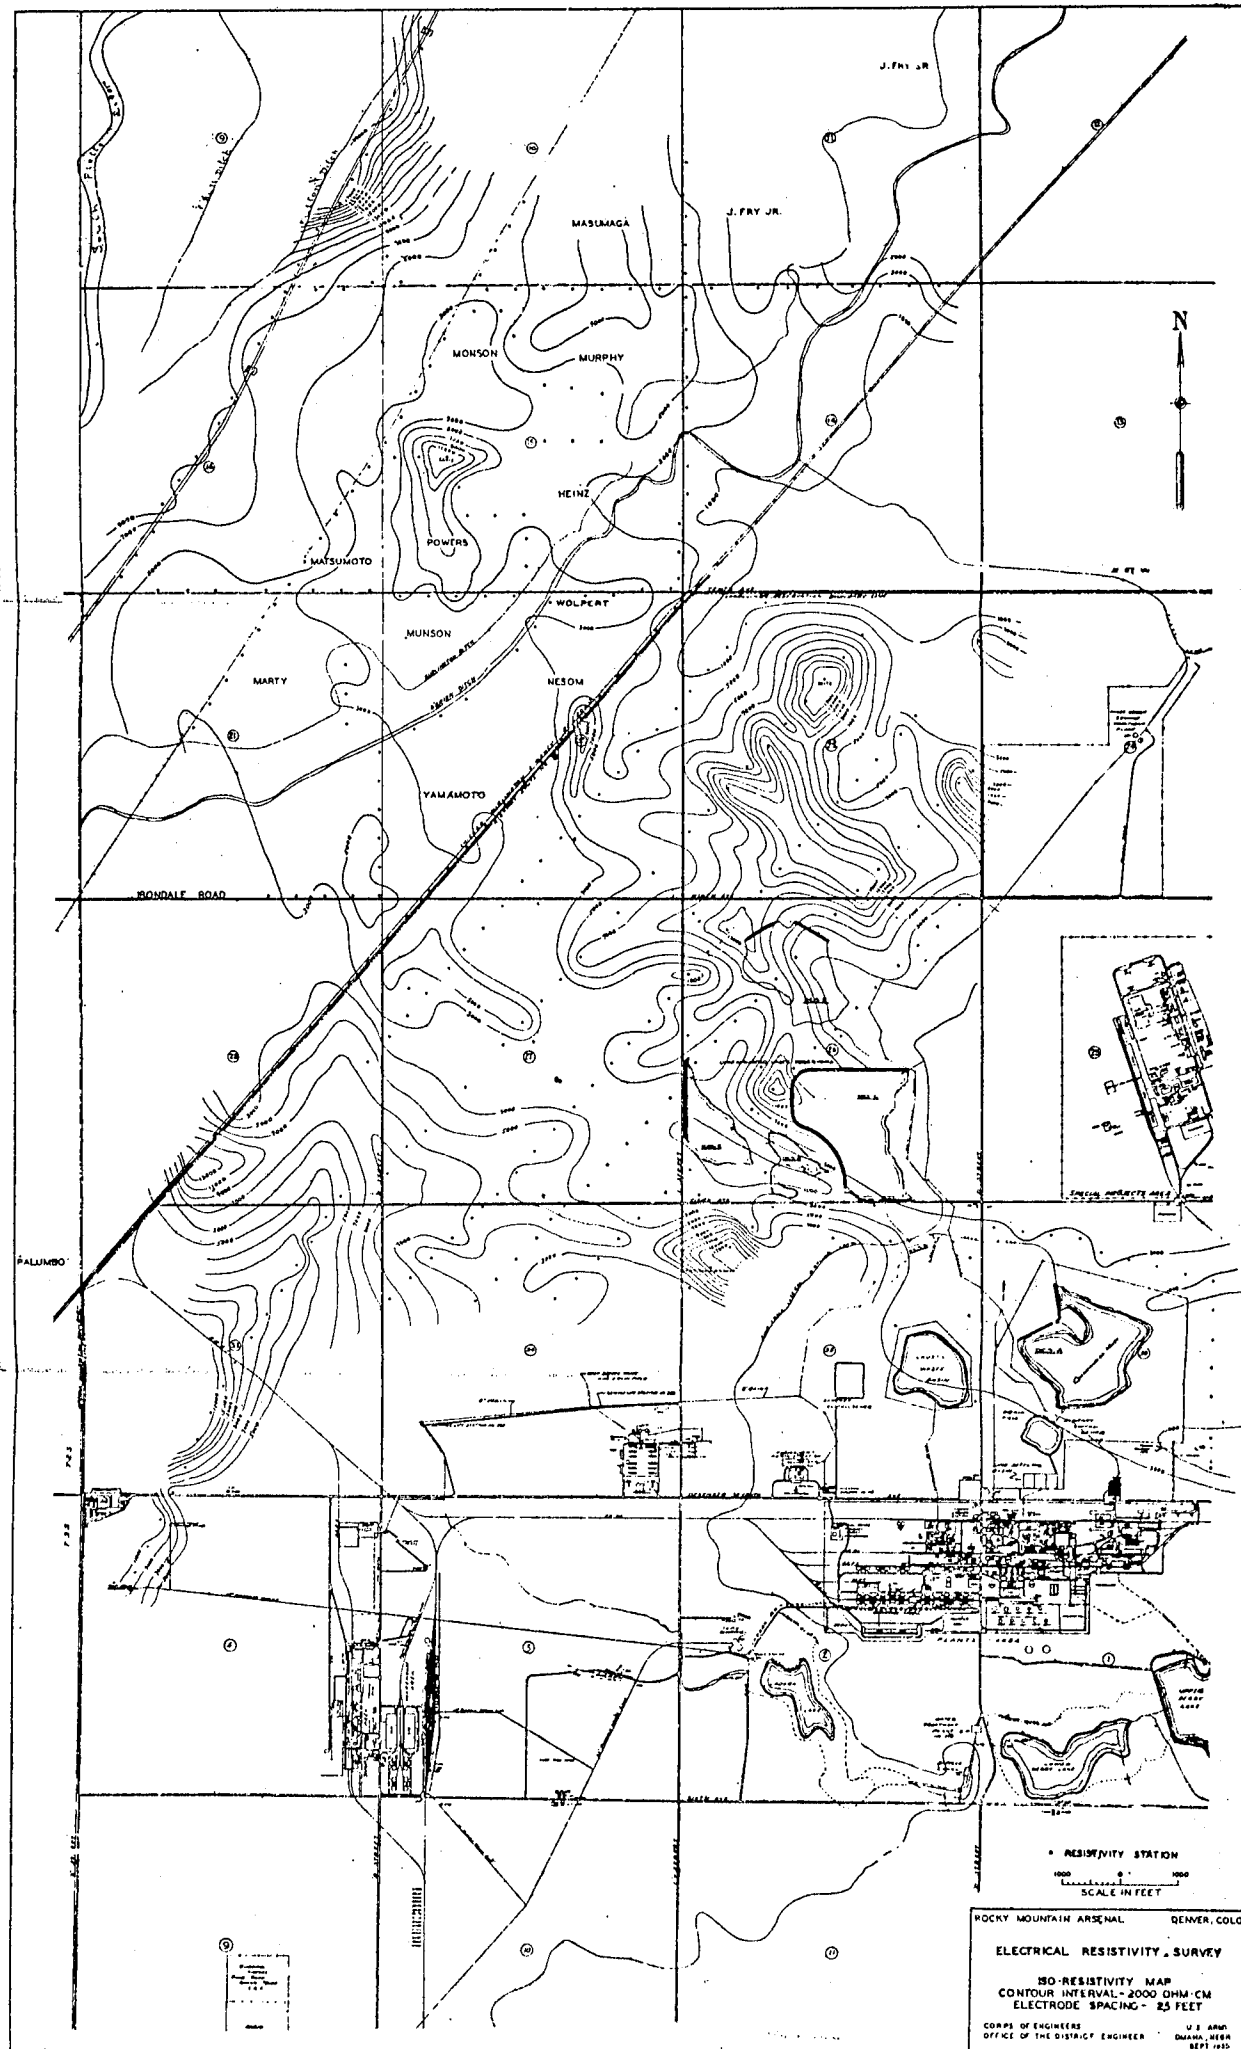
ROCKY MOUNTAIN ARSENAL DENVER, COLO.
 ELECTRICAL RESISTIVITY SURVEY
 ISO-RESISTIVITY MAP
 CONTOUR INTERVAL - 2000 OHM-CM
 ELECTRODE SPACING - 25 FEET
 CORPS OF ENGINEERS U.S. ARMY
 OFFICE OF THE DISTRICT ENGINEER DENVER, COLO.
 SEPT 1955

The electrical resistivity survey revealed two areas which have pronounced low resistivity values. The general trend of these "low" areas is in a northwest direction. The limits of the "low" area near the northern boundary line have not been delineated as thoroughly as the "low" area northwest of the Contaminated Waste Reservoir A. It may be noted that the "low" areas follow a trend toward the area being contaminated, namely the Powers property, as shown on the iso-resistivity maps, Plates Nos. 2, 3, 4, and 5.

If the source of contamination is from the infiltration of disposal wastes into the ground water, it is reasonable to assume that the "low" areas may be the limits of the contamination.
